Washing Your Cares Away

Gaining an equipment wash rack upgrade as part of the turf management center master plan.

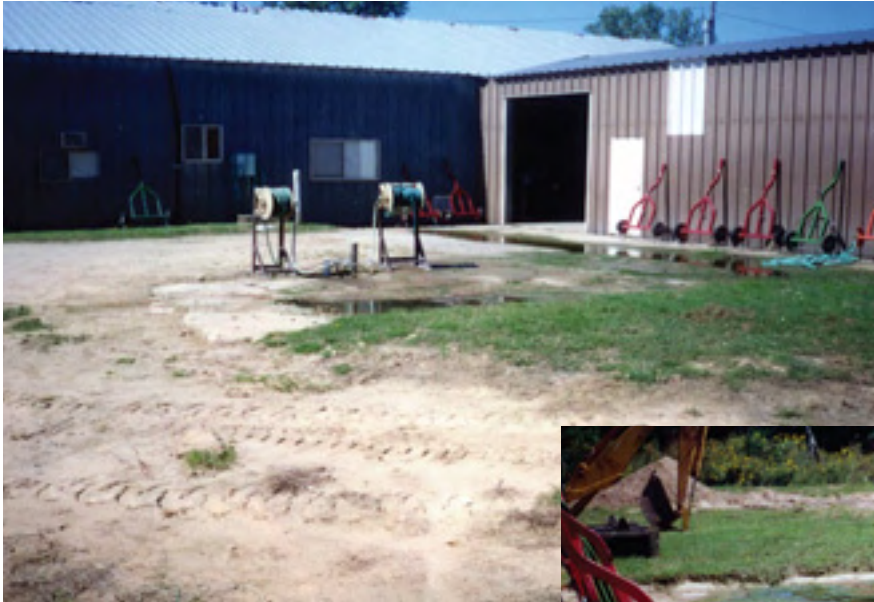
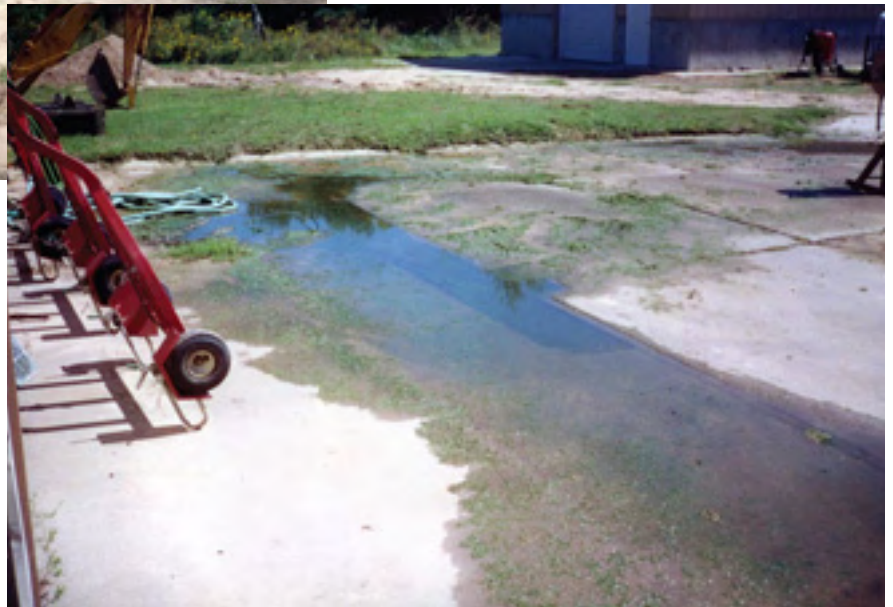
Failing drains and stagnant water plagued Prairie Dunes Country Club's wash pad before the upgrade.

Superintendent Stan George had long felt the club needed a new wash rack system. The old wash pad consisted of two hoses on a 400-square-foot, irregular concrete base. Constructed from concrete left over from past projects, the uneven surface caused the accumulation of rinse water on the pad itself. In addition, the drains were failing, allowing unfiltered rinse water to stagnate above ground and potentially degrade groundwater.

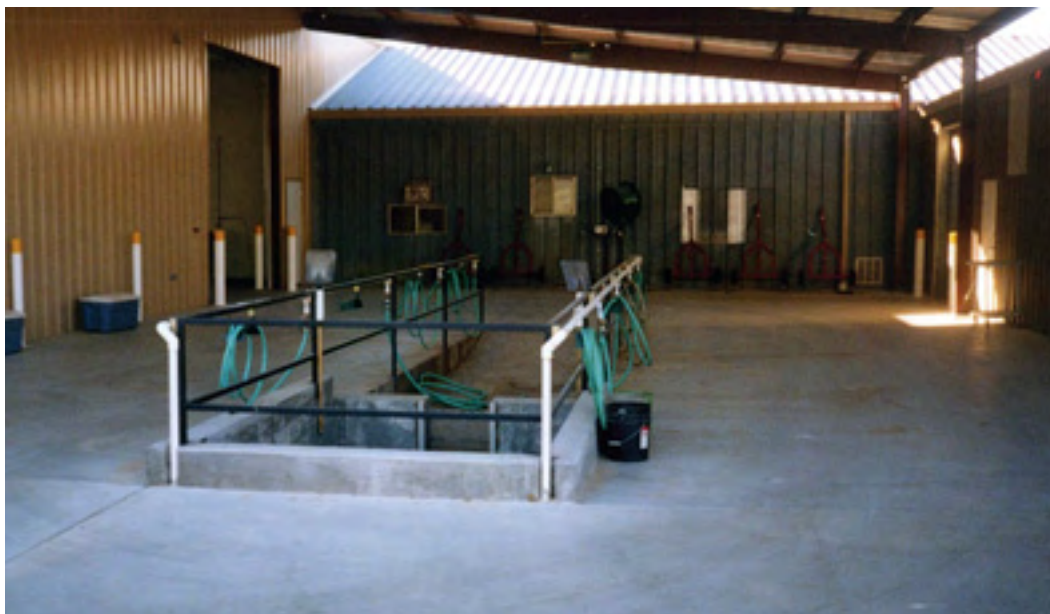
The redesigned and greatly improved wash pad at Prairie Dunes Country Club provides adequate collection and filtering of wash water.

water separator tank, much like a septic tank. The filtered water is discharged into a leach field.

The design of the system is quite simple. The concrete pad is slightly sloped to enhance rinse water and clipping movement into the collection pit from both sides. Rinse water is double screened to collect clippings before passing through a buried oil/
