# Protecting Water Quality On and Off the Golf Course

Design features for filtering fertilizer nutrients.

BY ERIC MILTNER

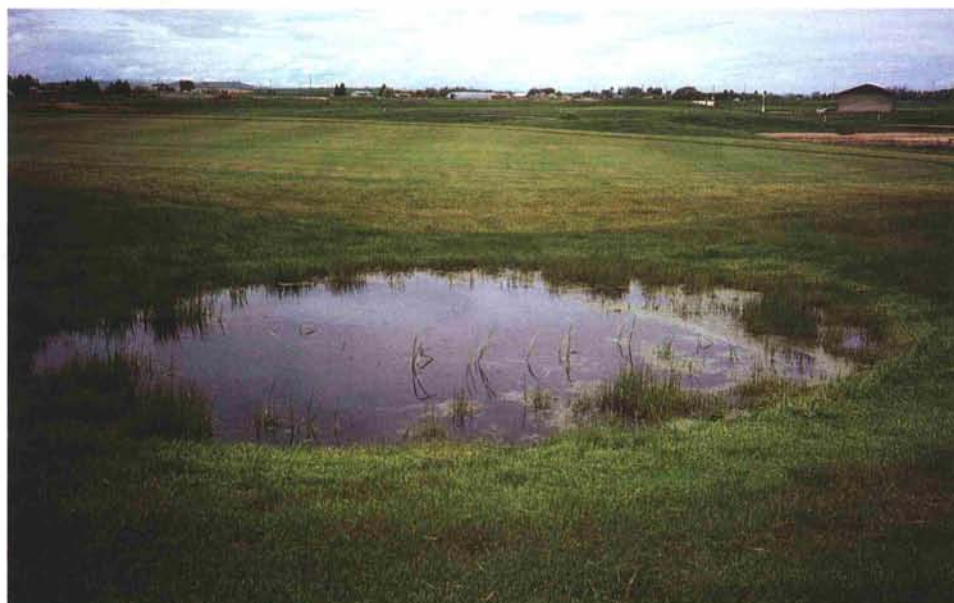
Wet cells that seasonally hold water are one way of potentially reducing fertilizer from leaving the property.

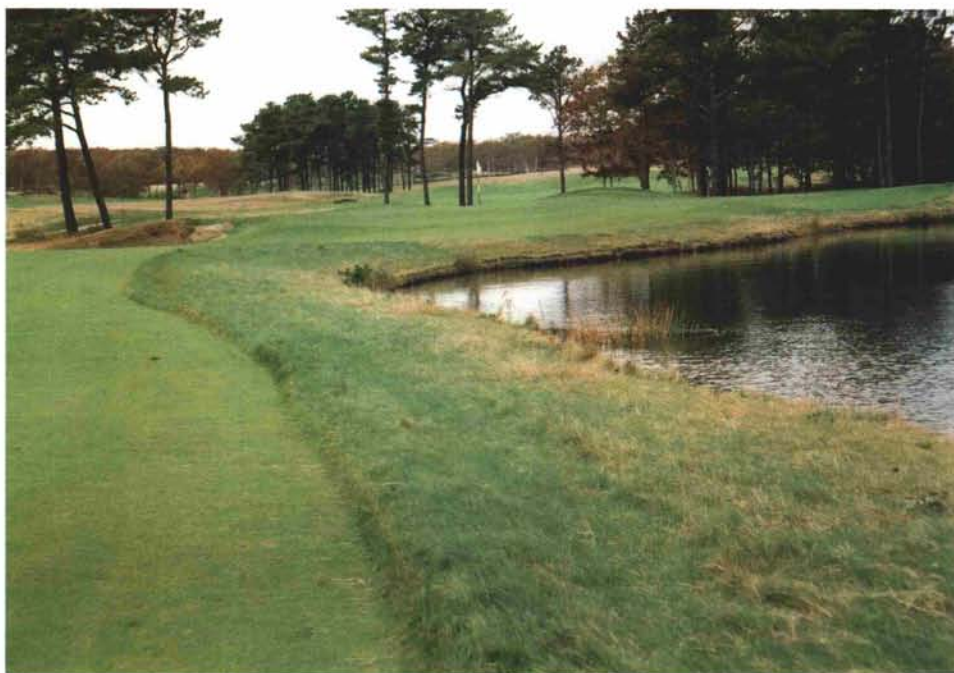
Streams and water features require very careful applications to the surrounding areas. Buffer strips help minimize nutrient and chemical introductions to the water.
